PARK RIVER BASIN  
WEST HARTFORD, CONNECTICUT

HARTFORD RESERVOIR NO.3 DAM  
CT 00002

PHASE I INSPECTION REPORT  
NATIONAL DAM INSPECTION PROGRAM

APRIL 1980

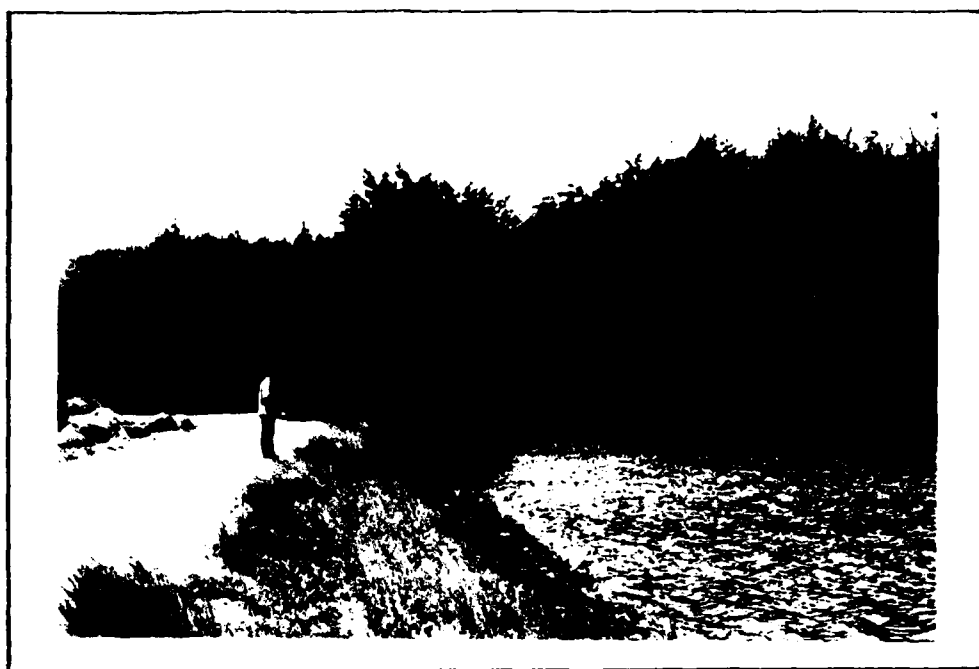
The upstream slope is relatively steep and the stability of the slope should be investigated. The root systems of the trees growing from the upstream face of the dam and in the vicinity of the downstream toe also present hazards to the structural integrity of the embankment. High winds could uproot the trees and dislodge portions of the embankment while the roots create potential seepage paths through the dam.

1. TREES AND VEGETATIVE COVER ON THE UPSTREAM FACE OF DAM.  
(11/13/79)

1. To investigate the source of the seepage at the downstream toe and recommend a method of seepage control.
2. To perform slope stability analyses to assess the need for stabilizing the embankment.
3. To direct the removal of trees from the upstream face of the dam and from the vicinity of the downstream toe.
4. To design and direct the installation of upstream controls for the high and low level outlet pipes.

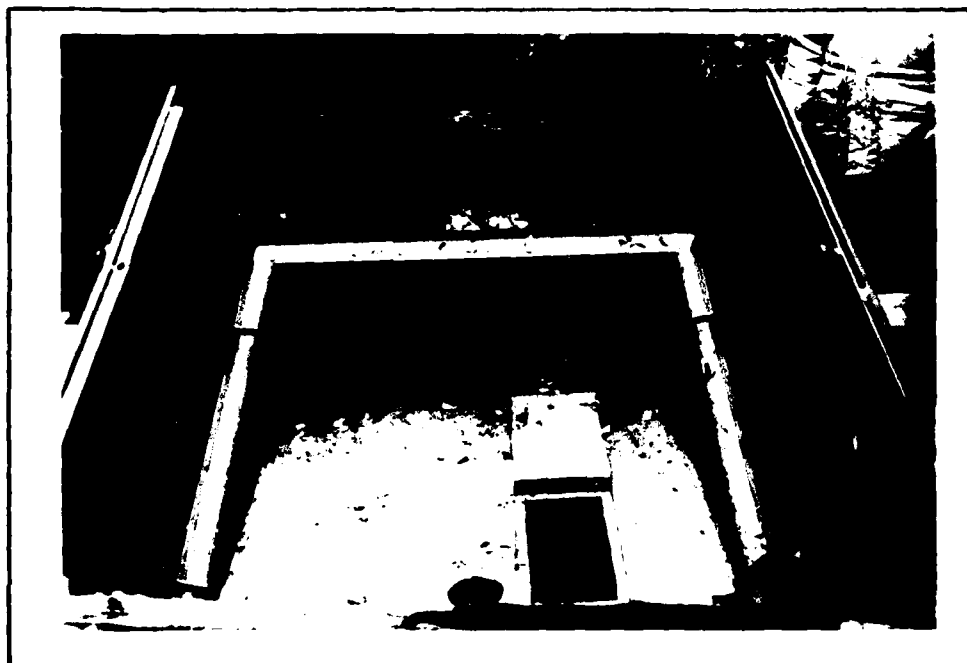
An outlet chamber houses the sluice gate for the diversion pipe which transfers water from Reservoir No. 3 to Reservoir No. 5. Access to this chamber is provided through two metal hinged doors as pictured on page C-3. The gate and outlet chamber appear to be in good condition.

6. ENCLOSURE FOR GATE SYSTEM WHICH CONTROLS DIVERSION DISCHARGE  
TO RESERVOIR 5.  
(11/13/79)
